**HomeCheck, Inc.**

# INSPECTION REPORT

1 Main Street  
Anywhere, VT

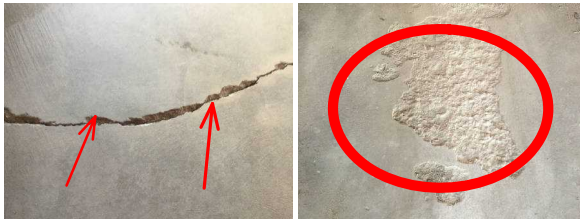
As Soon As Possible Floor/Foundation: Poured concrete - [Deficiencies present-recommend corrective action, Surface cracks/deteriorated floor surface areas, Floor cracks present, Floor settled/heaved, A qualified contractor is recommended to evaluate and estimate repair/replacement as needed](#)

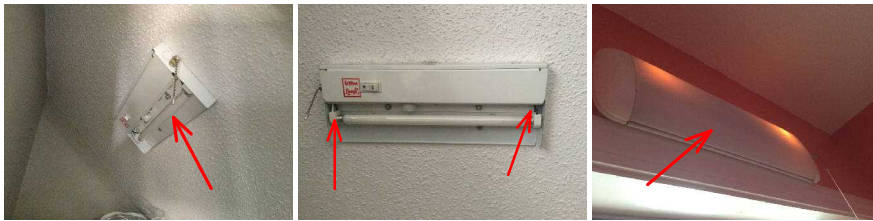
Unsatisfactory Electrical: Outlets and lighting circuits - Deficiencies present-recommend corrective action, Substandard electrical present, Lighting not working properly in loft closet and closet lights have missing lenses, exposed wires present. Also light in second floor right bedroom closet not working properly. A licensed electrician is recommended to evaluate and estimate repair/replacement as needed.

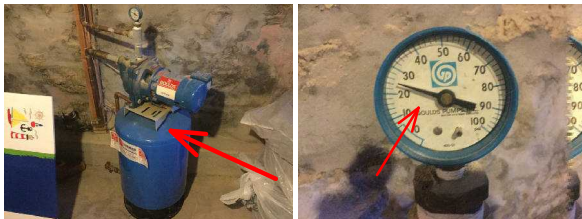
As Soon As Possible Service Line: Copper - Deficiencies present-recommend corrective action, Low water pressure present, pressure gage reads 25 psi only. Water pressure decreases even more when more than one water appliance is turned on at once, booster pump in basement not working. A licensed plumber is recommended to evaluate and estimate repair/replacement as needed
